## Xanbus Network Crossing with AEBus

CSB Number	855-0003
Date	December 14, 2020

AES Batteries with Xanbus Network Connections; 42-48-6650, 44-24-2800.

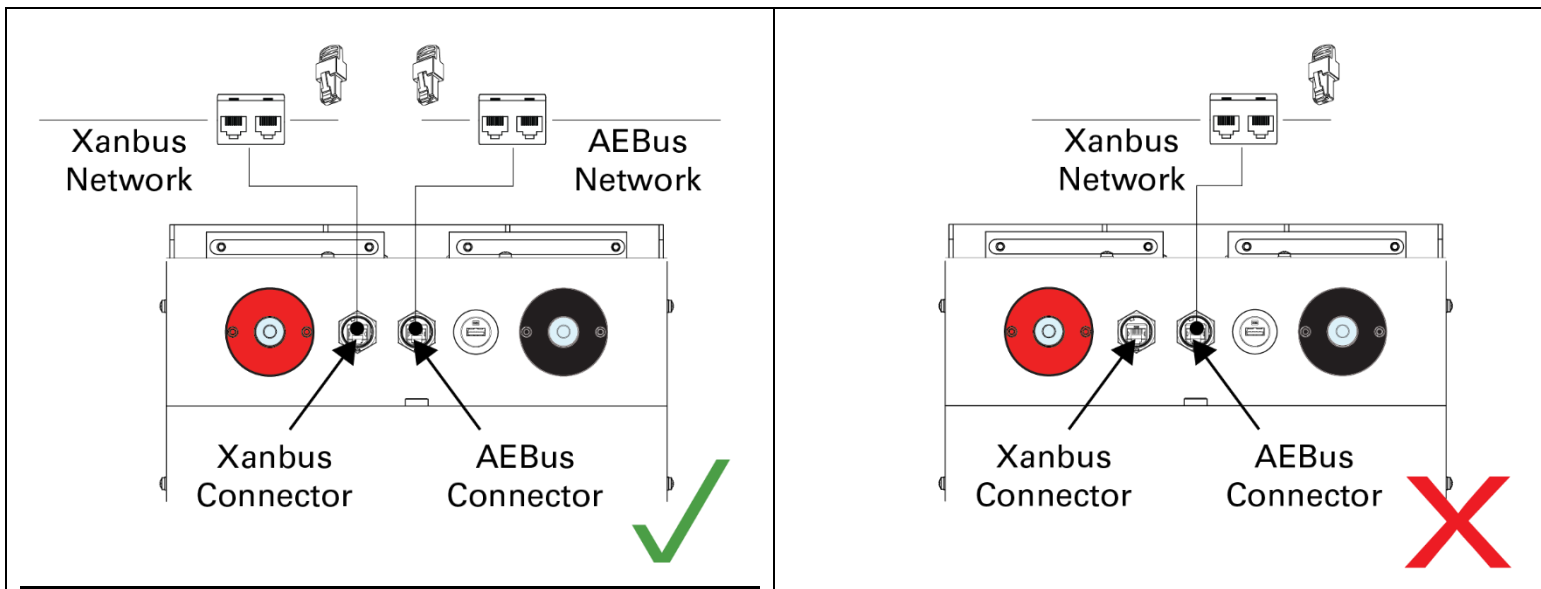
### REFERENCE DOCUMENTATION AND PROCEDURES

If an AEBus connector is installed into the Xanbus port of the battery, a short circuit will occur and may cause the wire connector, the Y connector, or the battery port itself to heat up and deform.
